Volvo Trucks North America, Inc.

RE: NHTSA Recall Campaign Number: Not Available *00V-246.106*
Volvo Trucks North America, Inc., Recall Number: RVXX0005

**SAFETY RECALL RVXX0005
NOVEMBER 2000**

SUBJECT: TRW Tie Rod Ball-Socket Assembly

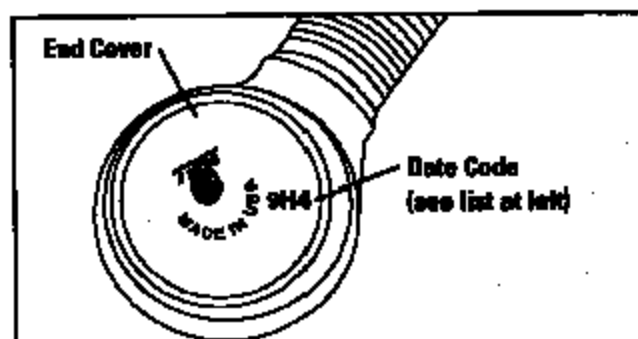
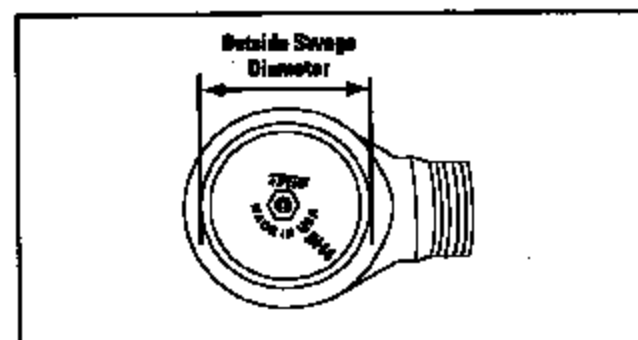
AND The date code on either socket end is any of the following: 9G1, 9G2, 9G3, 9G4, 9H1, 9H2, 9H3, 9H4, 9H6, 9J1, 9J2, 9J3 OR 9J4. If the date code begins with any number other than "9", it is not part of the campaign. If the letter is "A-F" or "K-M", it is not part of the campaign.

AND The sockets are "20 size" sockets. To identify the size: Measure the outside swage diameter. A 20 size socket will measure approx. 1 7/8". Any socket measuring 2 1/8" is a "24 size" socket, and is not part of the campaign.

NOTE: Any socket with "DL" stamped into the end cover is a different design, and IS NOT part of this campaign.

THEN Both socket ends need to be replaced using this kit.
